Fibre Reinforced Geopolymer versus Conventional Reinforced Concrete layers for the structural strengthening of RC beams

Abstract

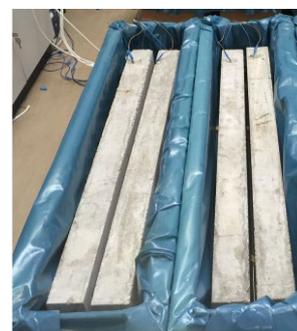
Figure 2. Accelerated corrosion setup

Impressed current technique was used to simulate the effect of corrosion on the steel reinforcement of the additional layer (Figure 2).

A constant current of 300 mA was applied for 30 days between the reinforcement bars (anode) of

the additional layer and a copper mesh (cathode) at the bottom surface of the container which was connected to the negative terminal of a DC power supply (Figure 2).

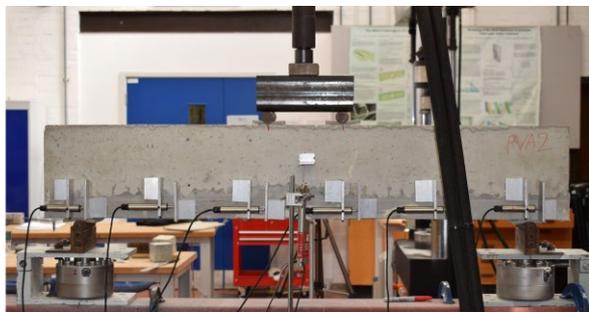
Figure 3. Four-point bending setup

For the evaluation of the structural performance of the strengthened beams, four-point bending tests were conducted and the load versus mid-span displacement was recorded. In addition to the load-deflection results, Linear Variable Displacement Transducers (LVDT) were used to monitor the slip at the interface between the layers and the initial beams (Figure 3).

The effective span in all the examined specimens was equal to 1200 mm and the specimens were tested under displacement control with a loading rate of 0.004 mm/s.
