Simple strengthening techniques for Non-Engineered buildings against seismic actions

Keywords: Non-engineered buildings, seismic upgrade, seismic strengthening.

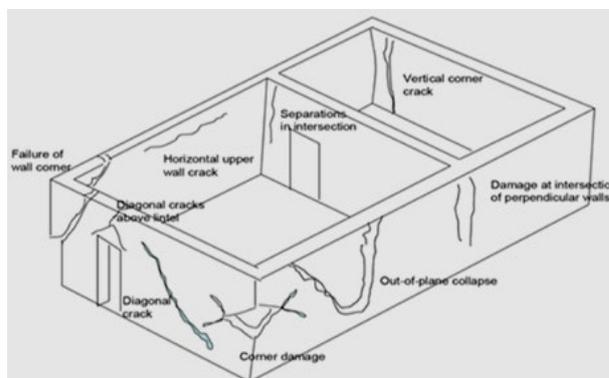
The seismic vulnerable features of masonry buildings include: Weak wall junctions (loss of box action), lack of integrity between load-bearing elements, lack of a diaphragm, long unsupported walls (behaving as cantilever walls), delamination of walls (reduction in load carrying capacity), large and unsymmetrical openings (lack of lateral load resisting elements and torsion effects) and soft-storey effects. Sequences of failure and occurrence of damage types suggest that the factors that govern damage are: (a) Corners are more likely to fail than mid-wall elements, (b) Any panel between two corner failures is unrestrained and is unlikely to remain standing, (c) Non-load bearing panels are more likely to fail than load bearing, (d) Elements generally fail progressively and (e) The failure of one element increases the probability of failure of neighbouring elements. Figure 1 depicts some of these failures.

Figure 1. Typical damage in masonry structures

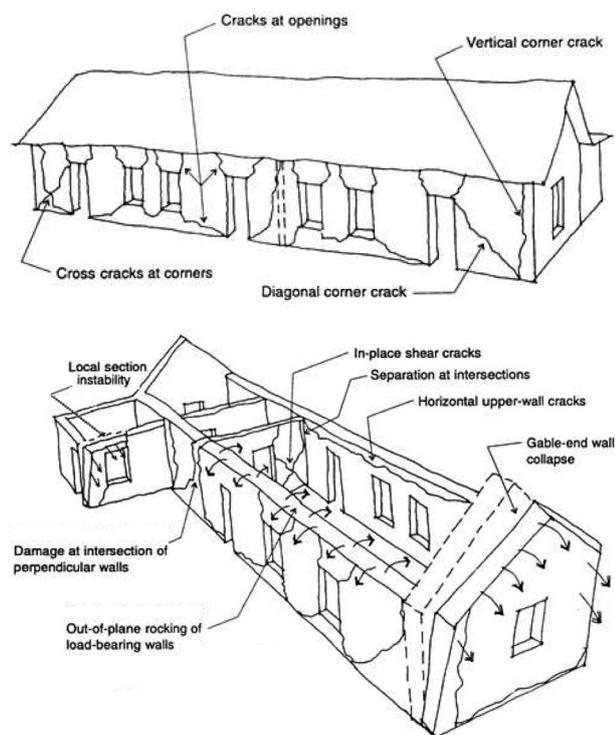
Typical types of damage to adobe construction can be summarised by the following: (a) Rocking of independent structural parts and in-plane diagonal and horizontal shear cracks, (b) Shear cracks due to pounding between orthogonal walls, (c) Pediment overturning in gable-end walls, (d) Gable-end wall overturning and possible toe crushing at their base, (e) Diagonal shear cracks in transversal walls. Gable-end wall overturning with portions of transversal walls, (f) Shear failure and sliding of peripheral bracing, (g) Diagonal tensile cracks from out-of-plane bending and diagonal shear cracks in transversal walls, (h) Separation and overturning of small wall segments, (i) Separation and overturning of large wall segments, (j) In plane shear cracks near openings

Figure 2. Typical damage in earthen (adobe) structures [2]

and masonry piers, (k) Corner dislocation and overturning and (l) Partial disintegration and loss of structural material. Figure 2 presents some of these failures.

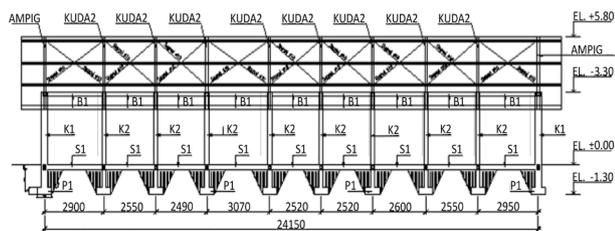
Two types of retrofitting strategies were adopted, depending on the structural capacity of the structures: (a) For the weakest structure, the strengthening approach was to add adequate RC frames on mat footings, as shown in Figure 3, and proper detailing of the connections of structural elements and (b) For the stronger building, the retrofit consisted of applying wire mesh to the infill wall elements and increasing the structural capacity of the foundation through the implementation of double tie beams next to the existing ones (Figure 4). For both structures, proper detailing was applied to the roof truss systems.

Figure 3. Implementation of new RC frames at a school building in Indonesia [3]

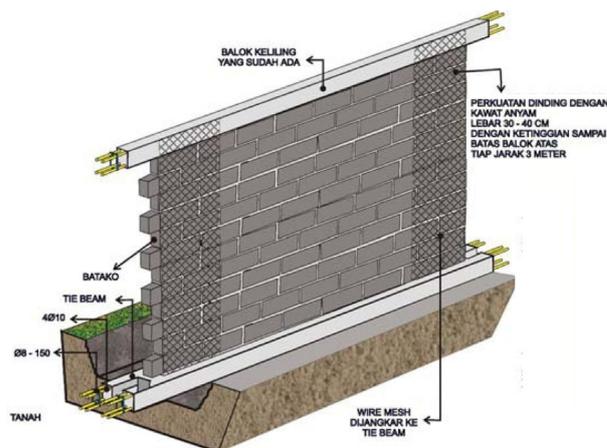
Figure 4. Strengthening of masonry infills at a school building in Indonesia [3]

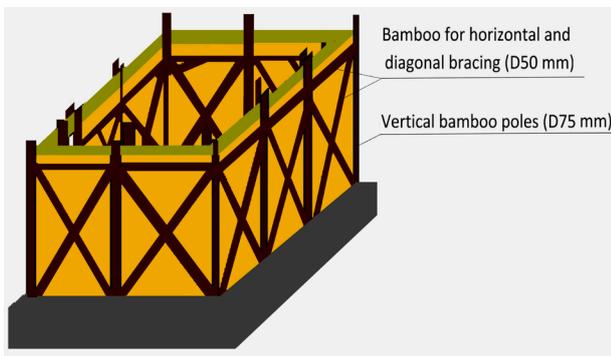
For the improvement of a mud house (Figure 5),

wooden bracing may be used along with metal straps at the connections. However, a good and low cost technique is the insertion of bamboo poles at the inner and outer side of the walls. A concrete plinth may fix the bamboo at the ground level. Then, holes are made through the walls to connect the bamboo poles at the inner and outer sides of the walls using bamboo splints and wire. At the top of the wall, these bamboo poles would be connected using the half bamboo splints in a truss pattern. This provides a lateral force resisting system.

Figure 5. Strengthening of mud houses, [5]

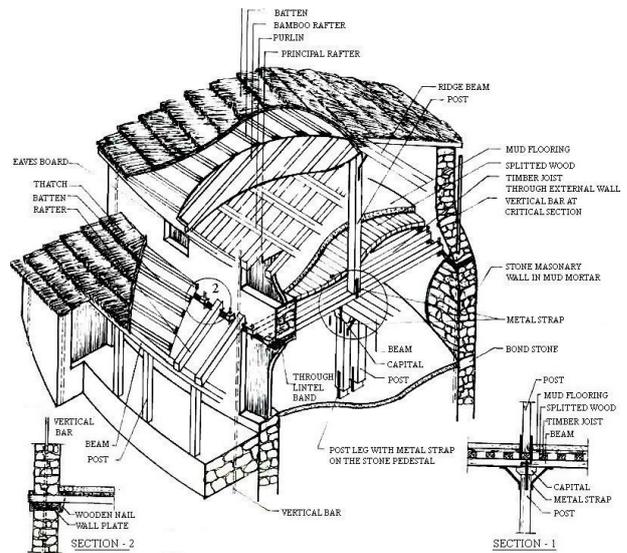
Most buildings in Nepal are made of stone and are not engineered since there is no process for Building Code enforcement in rural areas. Therefore, the damage from the 2015 Nepal earthquake was extensive. Simple strengthening techniques (Figure 6) that were suggested [6] comprise of: (a) Roof/floor retrofit with anchorage to walls thus creating diaphragms, (b) Insertion of bond stones in walls, bandages at different levels and splints at critical sections and (c) For timber frames, the creation of bracing (knee bracing, diagonal bracing) in order to strengthen beam-column connections and improving the anchorage of timber columns to the foundation.

Figure 6. Illustration of simple strengthening techniques in Nepal [6]

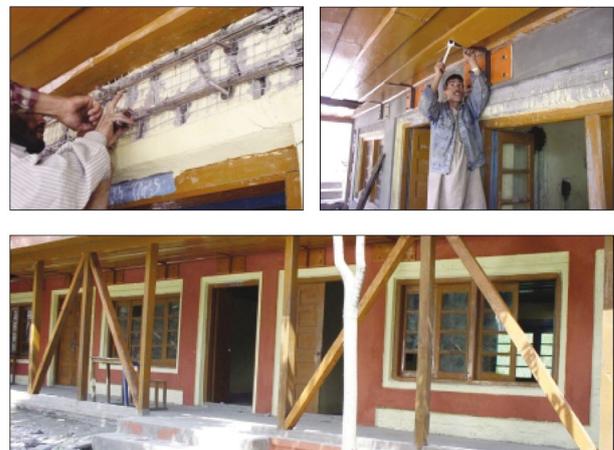
The strengthening (Figure 7) included: Installing

Figure 7. Strengthening with belts, roof anchoring and diagonal timber bracing [7]

vertical reinforcement at inside corners, anchoring the roof which, amongst other things, enforces diaphragm action at the roof level, in-plane bracing at the attic floor level (to reinforce the diaphragm), installing wire mesh to the walls creating reinforced belts on both sides, diagonal timber bracing on the perimeter and encasement of windows with reinforced vertical and horizontal belts.

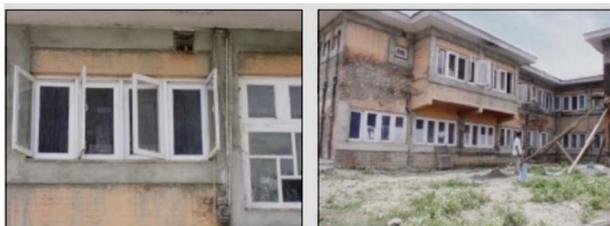
The strengthening of the hospital (Figure 8) consisted of installing vertical reinforcement in the corners, in-plane bracing at the attic floor level, anchoring the roof truss and placing encasement around openings.

Figure 8. Strengthening with belt encasement around openings [7]

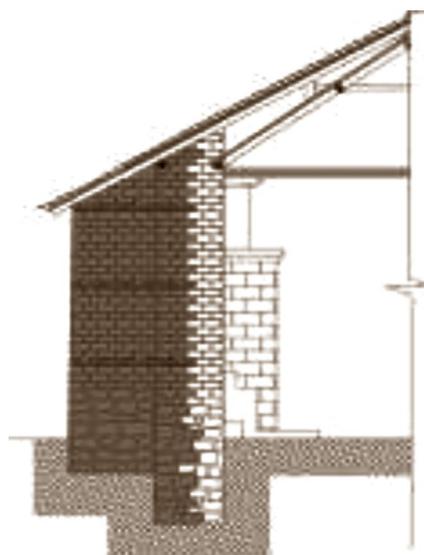
The strengthening technique that was applied [8] involved placing a combination of buttresses and bracing elements (i.e. corner keys, horizontal keys, bond beams and anchored tie beams). The reestablishment or the addition of buttresses (Figure 9) can efficiently address low or compromised out-of-plane capacity and minimise

Figure 9. Church of Kuno Tambo, Peru, cross section of new buttress [8]

lateral deflections, especially in walls of large spans.

Connectivity between the existing earthen walls and the new buttresses can be ensured by inserting horizontal timber elements at various heights. To ensure connectivity and substantial stiffness in corners between orthogonal walls and pillars, orthogonal or diagonal timber keys should be used. The insertion should be made in horizontal planes at various elevations and involve mostly the upper parts of the walls. For existing cracks, several processes that respect the historic fabric can be applicable, such as partial replacement of material, stitching, repointing and grout injections with mud based grouts. Furthermore, additional lateral restraint can be offered by the means of tie beams. This system is placed at the level of the top eaves, embedded across the entire thickness of the walls. It can be subjected to both axial tension and compression, given the dynamic character of seismic loads. Thus, for the system of ties to work both in tension and compression, an adequate anchoring system is needed. A double system of vertical timber anchors, attached close to the interior and exterior surfaces of each wall can be very effective. Finally, the implementation of an internal horizontal timber frame system, at the top level and through the entire thickness of the earthen walls can enhance substantially increase the capacity under lateral forces.
